CASE STUDY

CAT® 777E
TRUCK BODY TAIL

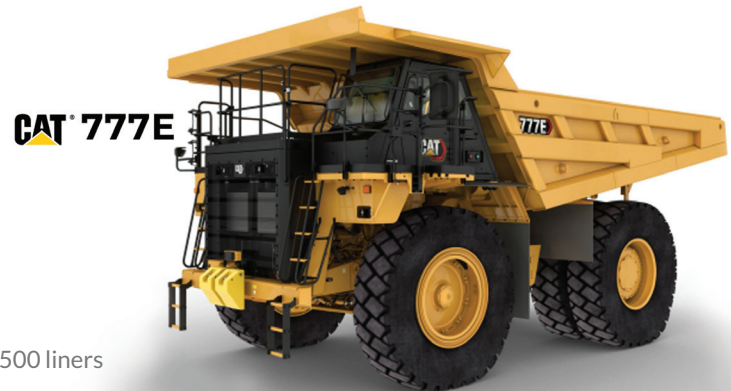
The company was experiencing excessive downtime, providing maintenance on their CAT® 777E haulers. They were installing AR500 30mm liners, which needed maintenance interventions every 1,200 Hours.

- **7X LONGER WEAR LIFE**
- **33% LIGHTER WEIGHT** Over standard AR500 liners

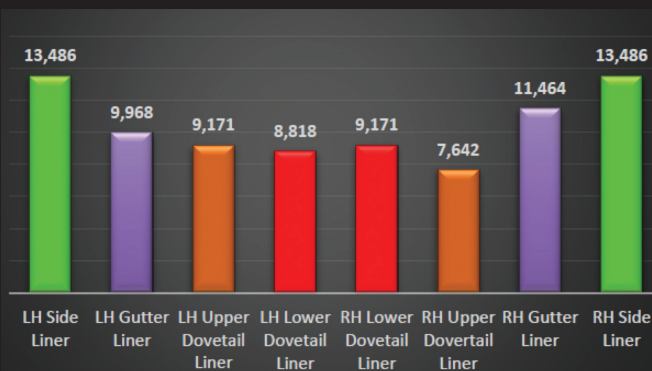
PROJECTED HOURS UNTIL 100% WORN

- Install CHROMEWELD 600 - 10mm on 10mm

- **7X LONGER WEAR LIFE**
- **33% LIGHTER WEIGHT**

Over standard AR500
