CASE STUDY

AGGREGATE BUCKET REBUILD®

WHO: SAND MINING COMPANY
WHAT: MULTIPLE BUCKET REBUILDS
WHERE: SAND MINING OPERATION
SERVICING WISCONSIN, USA

INDUSTRY: AGGREGATE / SAND
CHALLENGE: HIGH ABRASION
SOLUTION: BUCKET REBUILDS WITH QT-PLUS® & CHROMEWELD OVERLAY

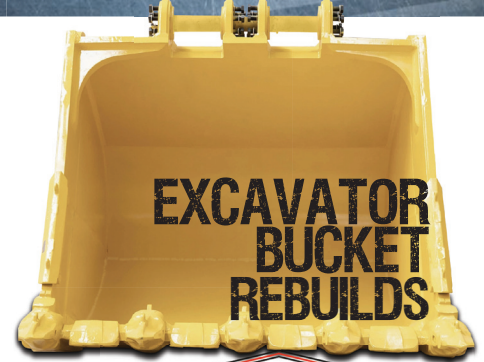
Client was experiencing excessive wear on their OEM excavator buckets moving sand in Wisconsin in this high-stress, high-grinding and high-abrasion environment.

High abrasion moving sand used in fracking causing excessive excavation bucket deterioration when mining sand. The result was excessive wear leading to structural issues and decreased productivity throughout their entire system.

Operation is more productive by rebuilding the BUCKETS using...

QT-PLUS AND CHROMEWELD

JADCO rebuilt excavation bucket bottoms using JADCO proprietary QT-PLUS® & CHROMEWELD™ Overlay on each of the client's buckets.

JADCO products provide 500 BHN through hardness, superior abrasion resistance over A514 or T-1 OEM mild steel, resulting in less downtime, and reduced labor expense.

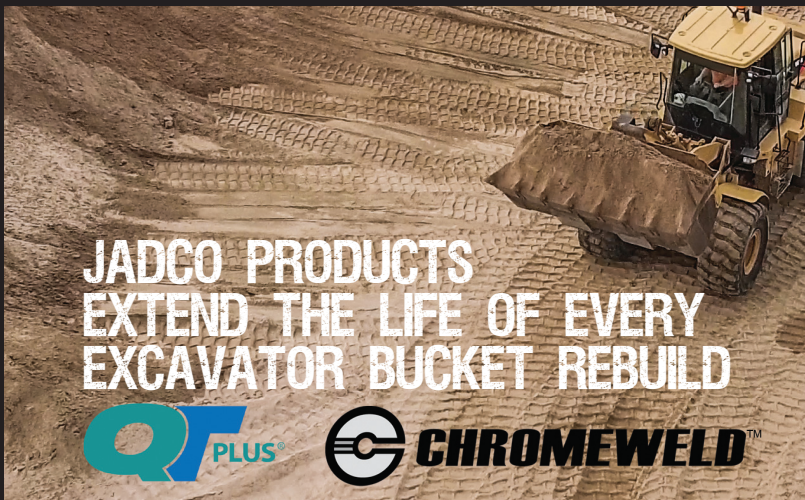
**JADCO PRODUCTS
EXTEND THE LIFE OF EVERY
EXCAVATOR BUCKET REBUILD**
