CASE STUDY

AGGREGATE
HOPPERS

**JADCO
HOPPER
LINERS**

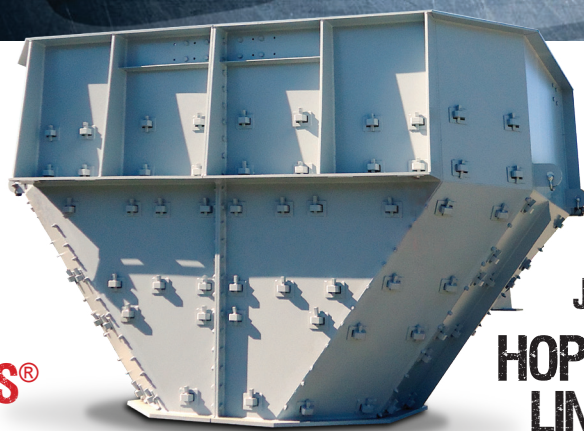
Operator was experiencing excessive wear in 7 hoppers in their concrete block plant, due to non-stop abrasion and high moisture, negatively effecting productivity throughout their entire system.

Non-stop abrasion & high moisture moving sand & stone causing hopper deterioration and mixing of material between bins. The result was excessive corrosion leading to structural issues throughout their entire system.

Installed JADCO Hopper liners using our proprietary QT-PLUS® in each of clients 7 hoppers. JADCO QT-PLUS® provides superior abrasion and wear resistance over OEM mild steel.

Our solution reduces wear, minimizes corrosion, and reduces downtime by eliminating the need for frequent liner replacements.
