JADCO CASE STUDY

PC7000 SHOVEL REBUILD

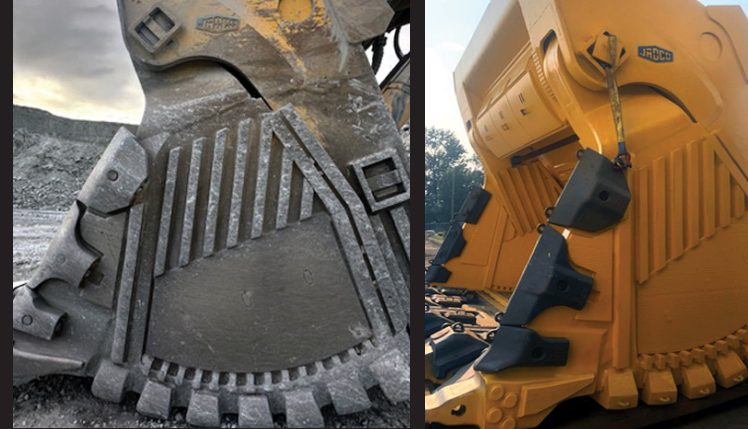
The mining customer had an existing shovel that had been in service for 24 months, 6 months longer than expected and utilized 2" AR 400 bars across the floor, backwall, and bottom ski's.

Enhanced with QT-PLUS & CHROMEWELD 600, it took ~9 months to begin showing any kind of rounding of edges in the most extreme impact/abrasion areas.

- CW600 overlay on the floor and cheeks
- JADCO QT-PLUS as tumble bars and edge protection

- QT-PLUS SHOWED ONLY MINOR EDGE ROUNDING AFTER NINE MONTHS
- CW 600 FLOOR DOCUMENTED WITH NEGLIGIBLE WEAR
